IN RE: ETHICON, INC., PELVIC REPAIR SYSTEM PRODUCTS LIABILITY LITIGATION	Master File No. 2:12-MD-02327 MDL 2327 JOSEPH R. GOODWIN U.S. DISTRICT JUDGE
THIS DOCUMENT RELATES TO: <i>Wave 3 Cases</i>

Intentional Oxidation of Prolene Mesh – Part 2

Supplemental Report of Dr. Shelby F. Thames

September 28, 2016

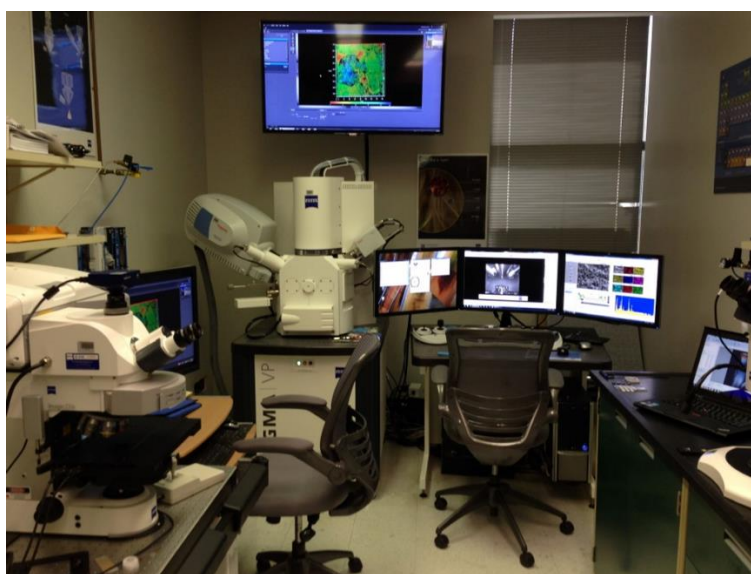
Figure 10. Zeiss Sigma VP FEG-SEM

Digital microscopy and scanning electron microscopy (SEM) of the before and after fiber exposure samples were conducted with a Keyence VHX-600 digital microscope (Figure 9) and a Zeiss Sigma VP FEG-SEM (Figure 10). One can readily observe oxidation effects upon Prolene as demonstrated by light microscopy and SEM fiber images (Figures 11 and 12, respectfully); before and after UV exposure. As a result of UV exposure, as described herein, Prolene fibers were grossly embrittled and demonstrated deep cracks resulting in fiber rupture via crack propagation.
